DEPARTMENT OF TRANSPORTATION
Structure Maintenance & Investigations

Bridge Number : 42C0317
Facility Carried: WATTS VALLEY RD
Location : 5.59 MI E/O PITTMAN HILL
City :
Inspection Date : 05/09/2018

Bridge Inspection Report

STRUCTURE NAME: WATTS CREEK

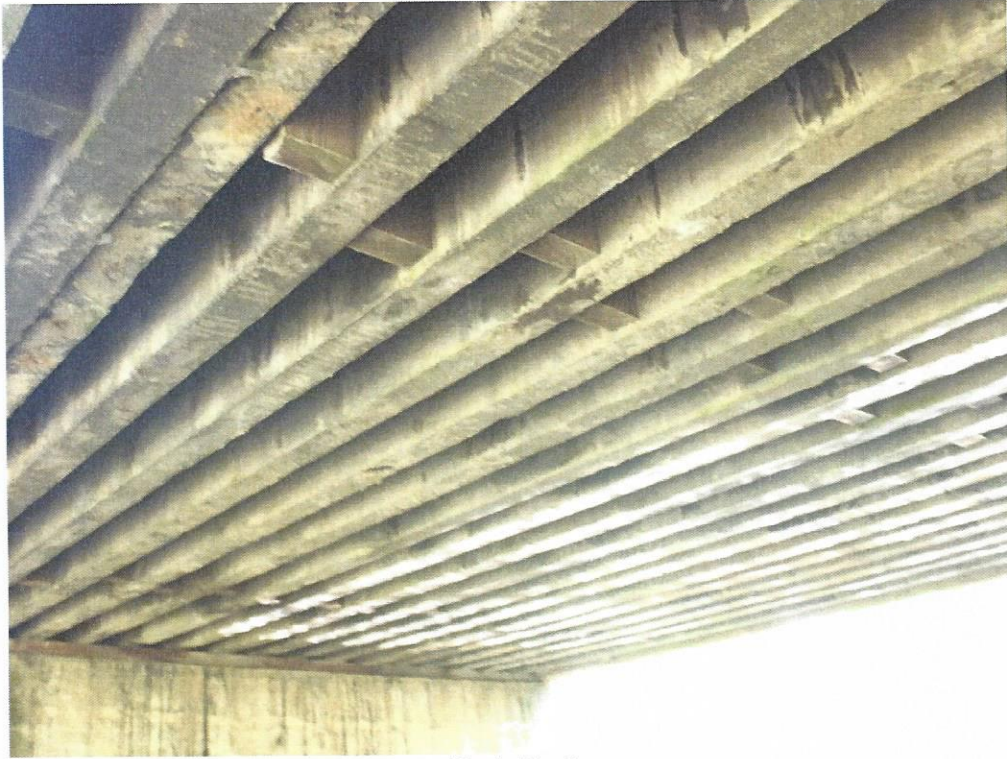
Photo No. 3

Typical view of the soffit looking towards the right from the left side of Span 1.

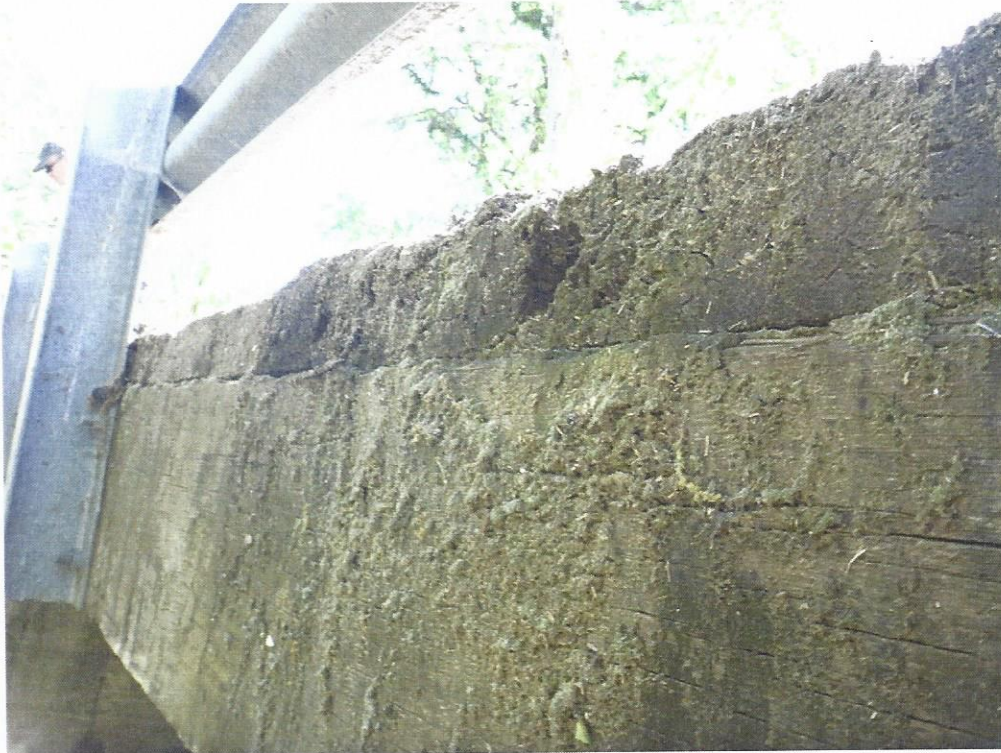
Photo No. 4

(31)										
There are dry white stains on the bottom surface of the timber deck planks between the timber girders at several random locations. The timber was probed with a geology pick and no section loss was detected.										
(31-1140)										
The outer 6 inches of the left and right edge of the timber deck are showing signs of decay and rot (see Photo 4).										
(31-510-3220)										
There are 0.25 inch wide transverse cracks spaced at 8 to 12 inches apart in the asphaltic concrete overlay (see Photo 1 from the BIR dated 5/17/2016). The cracks follow the edges of the timber deck planks.										
111			Girder/Beam-Timber	2	120	m	120	0	0	0

The outer 6 inches of the left and right edge of deck are showing signs of decay.
